Comparative Landscape Photographs of the Lonely Dell Area and the Mouth of the Paria River

By Robert H. Webb and Richard Hereford

Pamphlet to accompany
Geologic Investigations Series I-2771

2003

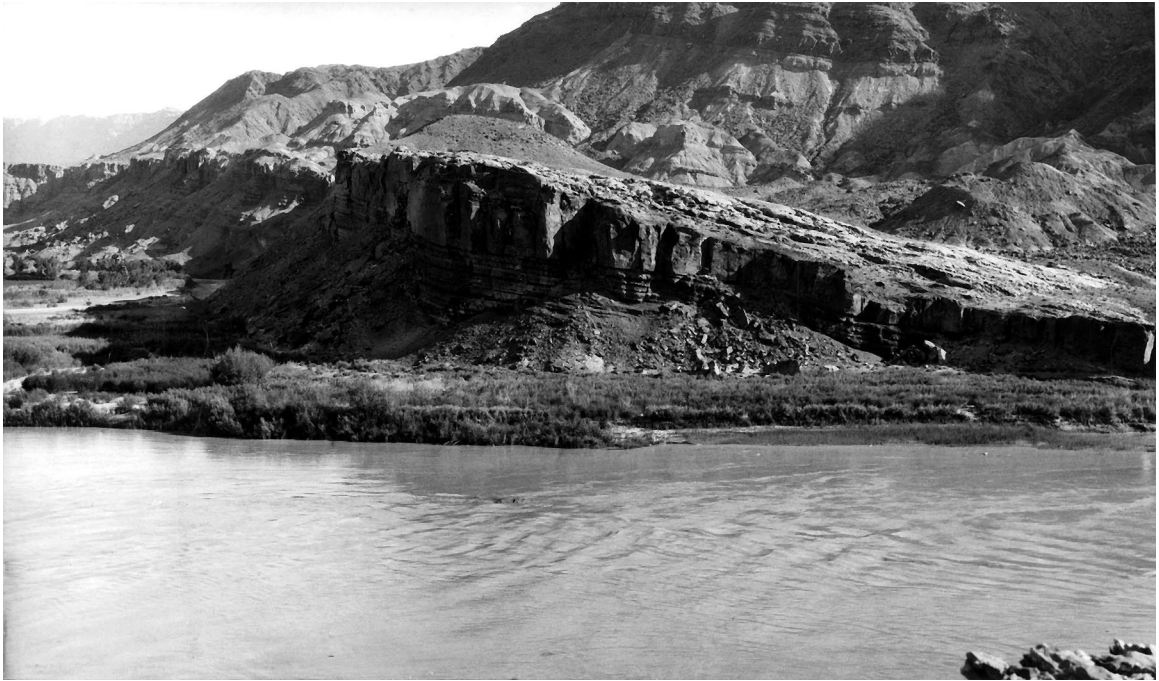
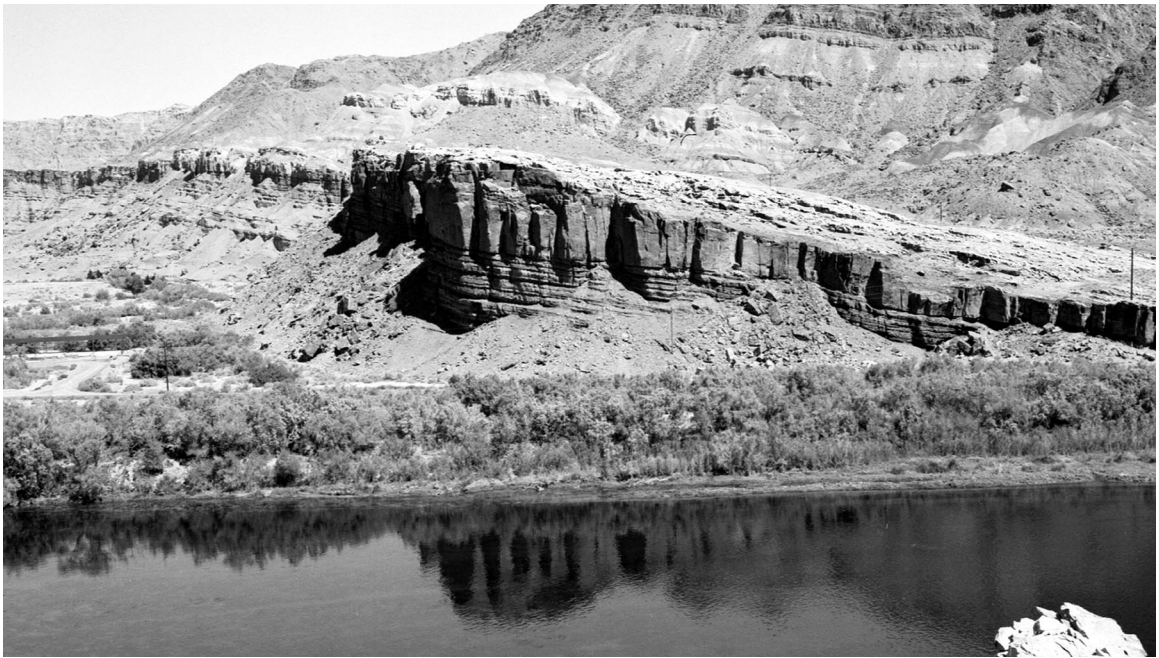
Photograph site 11.—Continued

June 6, 1915. Gregory photographed this view of the gently dipping Shinarump Member of the Chinle Formation (unit Tcs) along the northwest strike of the Echo Cliffs monocline. The low riparian vegetation is mostly seep willow and arrowweed. (*Photograph by Herbert E. Gregory, 286, courtesy of the U.S. Geological Survey Photographic Library.*) **August 22, 1972.** At the time of this photograph, tamarisk dominated the floodplain vegetation. The gaging station on the Colorado River at Lees Ferry is just upstream of this camera station. (*Photograph by Raymond M. Turner, U.S. Geological Survey, Stake 708b.*)

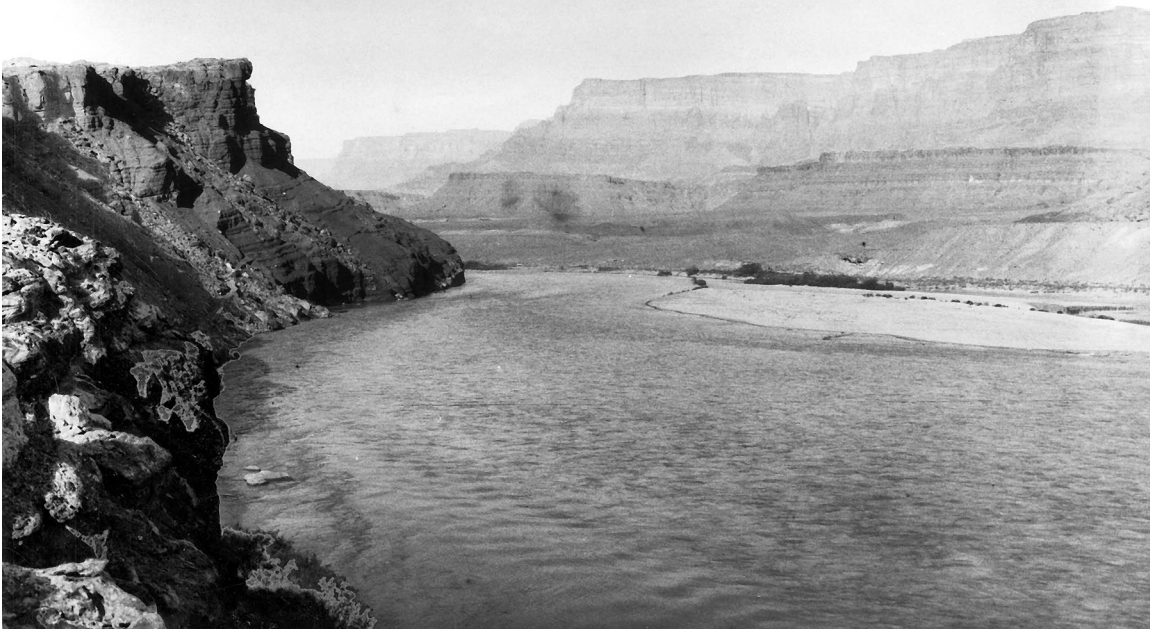
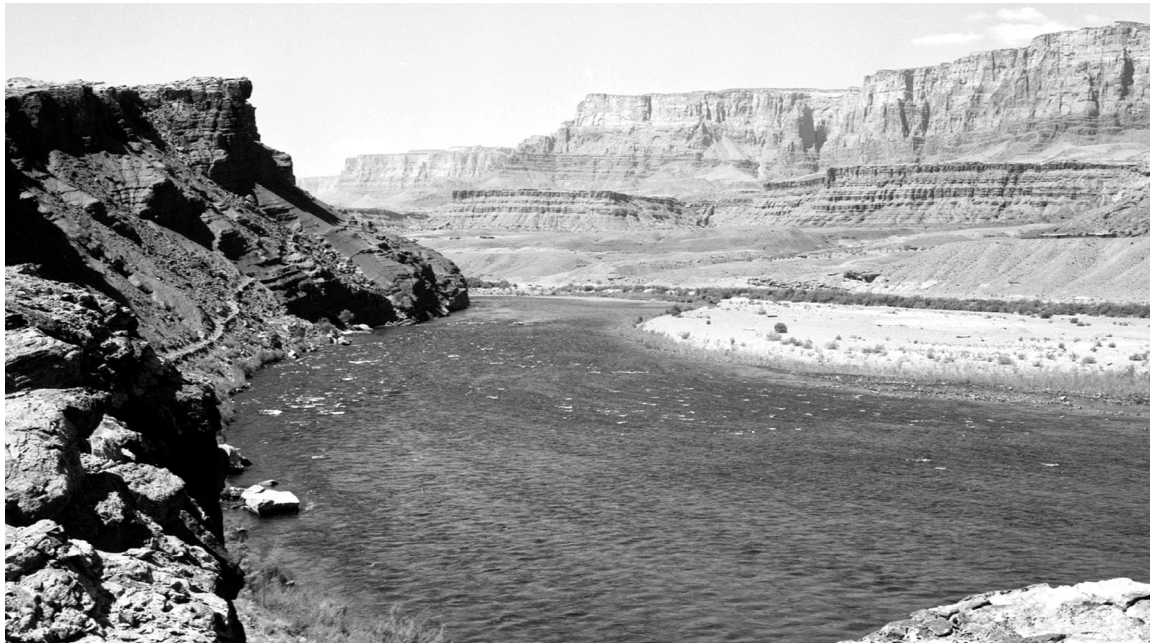
Photograph site 11.—Continued

June 6, 1915. H.E. Gregory's southwest-facing downstream view from a camera position near that of F.L. Ransome's ca. 1920 photograph shows the Colorado River in flood. The discharge is high enough that the large talus block (see Ransome's ca. 1920 photograph) in the center of the Colorado River is covered. A thin band of riparian vegetation, probably seep willow, marks the distant mouth of the Paria River. Sand mantles the delta area. (*Photograph by Herbert E. Gregory, 287, courtesy of the U.S. Geological Survey Photographic Library.*) **August 22, 1972.** Most of the sand has been stripped from the surface of the delta, particularly near the river. Scattered shrubs and willows are on the surface of the delta, and a dense line of tamarisk marks the channel of the Paria River in the background. (*Photograph by Raymond M. Turner, U.S. Geological Survey, Stake 709.*)

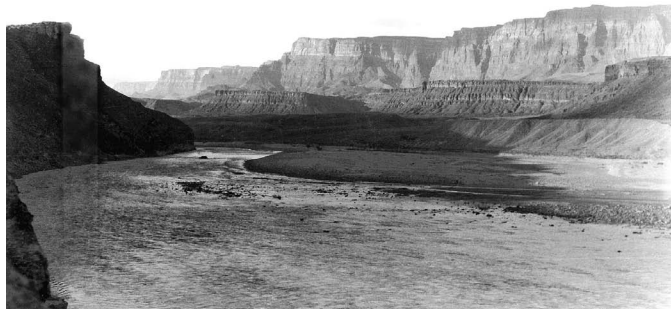
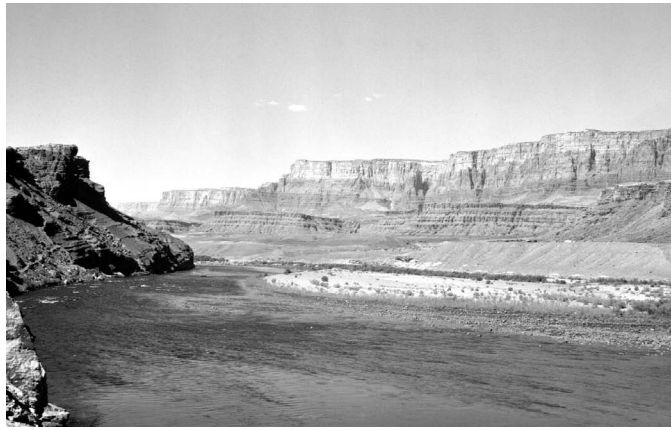
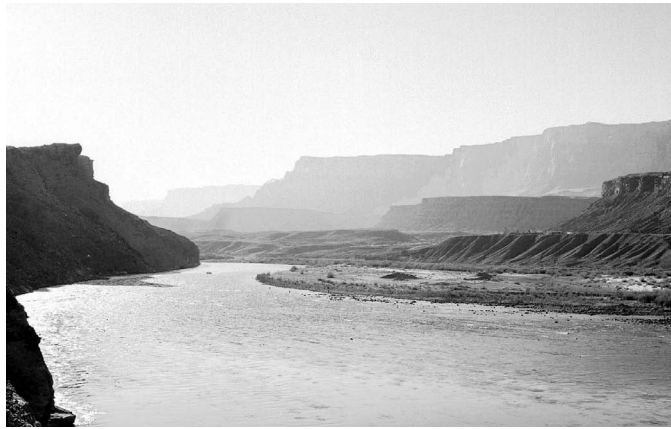
Photograph site 11.—Continued

ca. 1920. F.L. Ransome was a geologist with the U.S. Geological Survey interested in mineral deposits in the region. Possibly because of Charles Spencer's claims that the Chinle Formation at Lees Ferry contained recoverable gold, Ransome visited the site and took several photographs. This view looking downstream shows the barren delta of the Paria River. (*Photograph by F.L. Ransome, 1359, courtesy of the U.S. Geological Survey Photographic Library.*) **August 22, 1972.** The delta remains mostly barren despite the large increase in tamarisk elsewhere at Lees Ferry. The light-colored deposits are active sand dunes (unit ea). The coarse gravel substrate of the delta may minimize the ability of tamarisk to colonize the site. A dense line of tamarisk appears on the edge of the delta in the background. (*Photograph by Raymond M. Turner, U.S. Geological Survey, Stake 707a.*) **December 20, 1989.** Riparian vegetation, primarily tamarisk, has increased in the center of the delta as well as along the Paria River at the base of the background hills. The spoil piles of several gravel pits are present in the midground. (*Photograph by Raymond M. Turner, U.S. Geological Survey, Stake 707a.*)

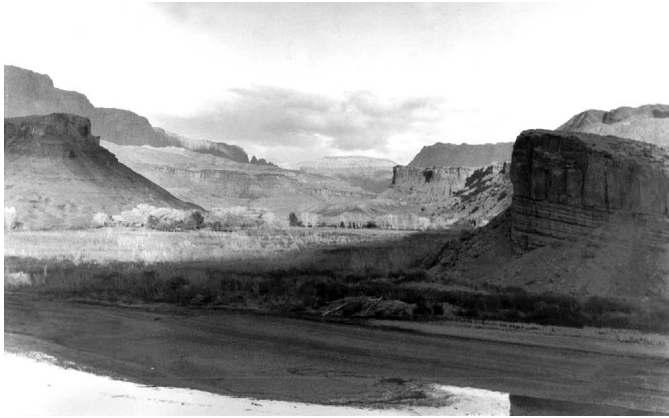
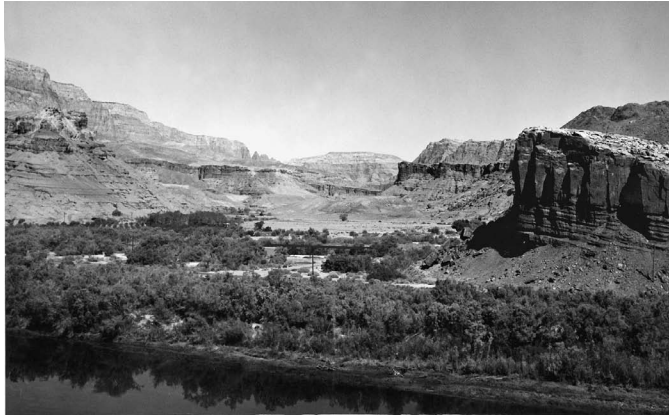
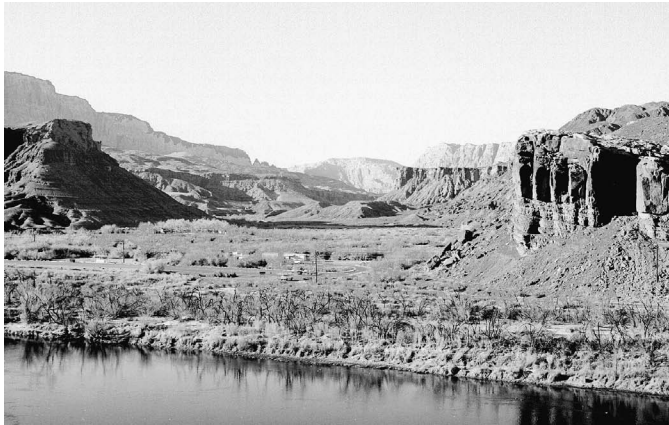
Photograph site 11.—Continued

ca. 1920. In Ransome's view of the mouth of the Paria River, the Lees Ferry ranch buildings are on the left. The mouth of the Paria had shifted downstream several years before Ransome's visit, and its former location is covered with willows and arrowweed growing on what was then the younger floodplain (unit yt) of the Colorado River. (*Photograph by F.L. Ransome, 1360, courtesy of the U.S. Geological Survey Photographic Library.*) **August 22, 1972.** In the foreground, a dense stand of tamarisk became established on the pre-dam alluvium (unit pda) on river right, primarily after closure of Glen Canyon Dam in 1963. The dense riparian vegetation at the mouth of the Paria River belies the arid climate of the site. (*Photograph by Raymond M. Turner, U.S. Geological Survey, Stake 707b.*) **December 20, 1989.** A fire in the early 1980s killed most of the tamarisk on river right, once again providing a view of the river terrace (unit pda). This tamarisk has since re-grown to nearly its former density. (*Photograph by Raymond M. Turner, U.S. Geological Survey, Stake 707b.*)

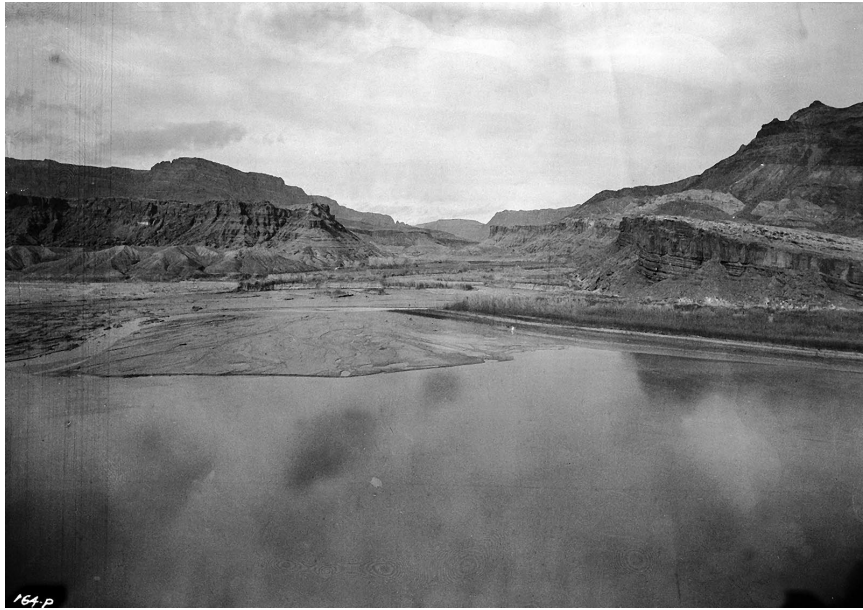
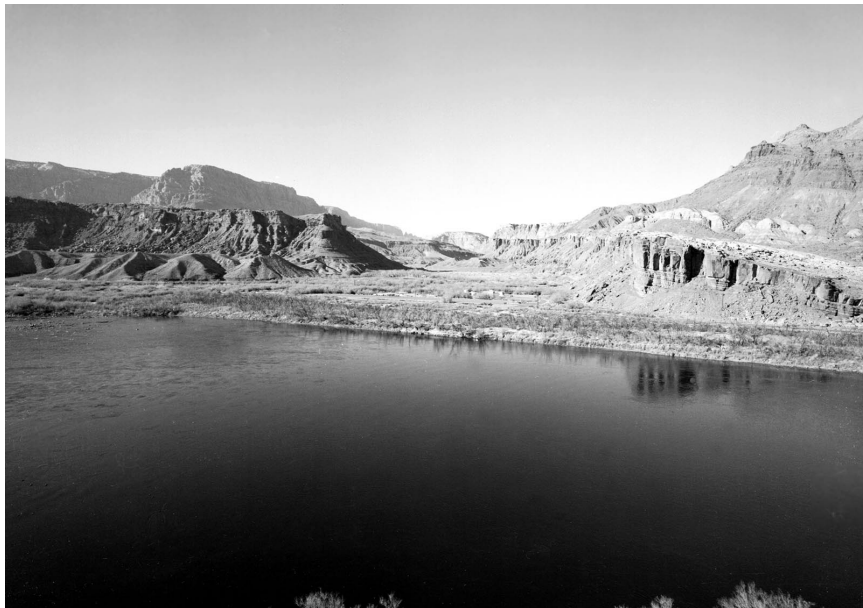
Photograph site 12.

December 28, 1889. In 1889, Franklin Nims, photographer for the Denver, Colorado & Pacific Railroad Company, photographed the mouth of the Paria River. His camera position was similar to that of O'Sullivan's 1873 photograph 16 years earlier (photograph site 11, p. 14), although Nims used a wide angle lens. Between 1872–1889, the intermediate terrace (unit it) was incised by a southeast shift of the Paria River, probably during one or more Paria River floods, as shown by the cutbank in the right midground. Generally, the channel of the Paria appears wider and deeper. (*Photograph by Franklin A. Nims, 261, courtesy of the National Archives.*) **December 20, 1989.** The stage of the Colorado River is higher than in 1889, covering the delta area shown in the 1889 photograph. The vegetation, on river right, in the midground is mostly tamarisk on the pre-dam alluvium (unit pda). The grove burned in the early 1980s, shortly before this photograph was taken. The tamarisk has since re-grown around the dead trees. (*Photograph by Raymond M. Turner, U.S. Geological Survey, Stake 1396.*)

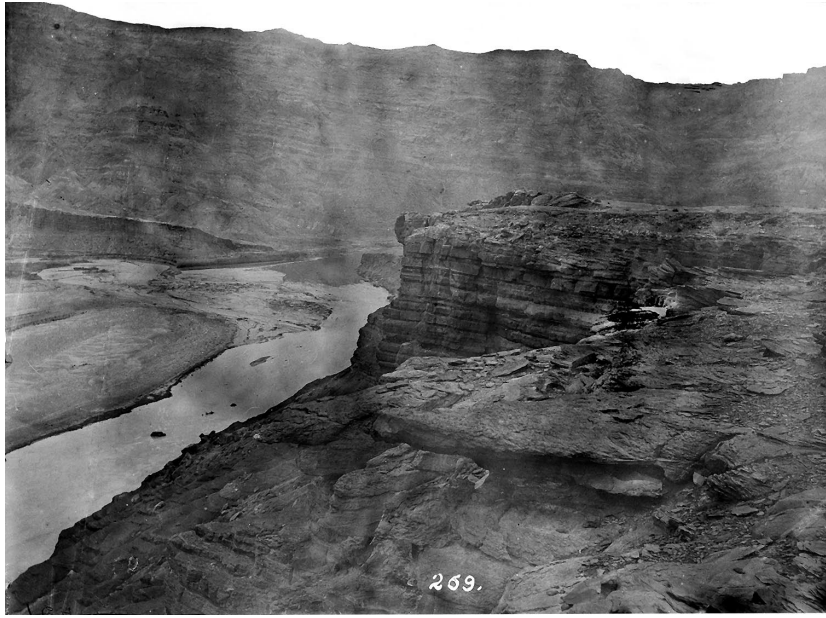
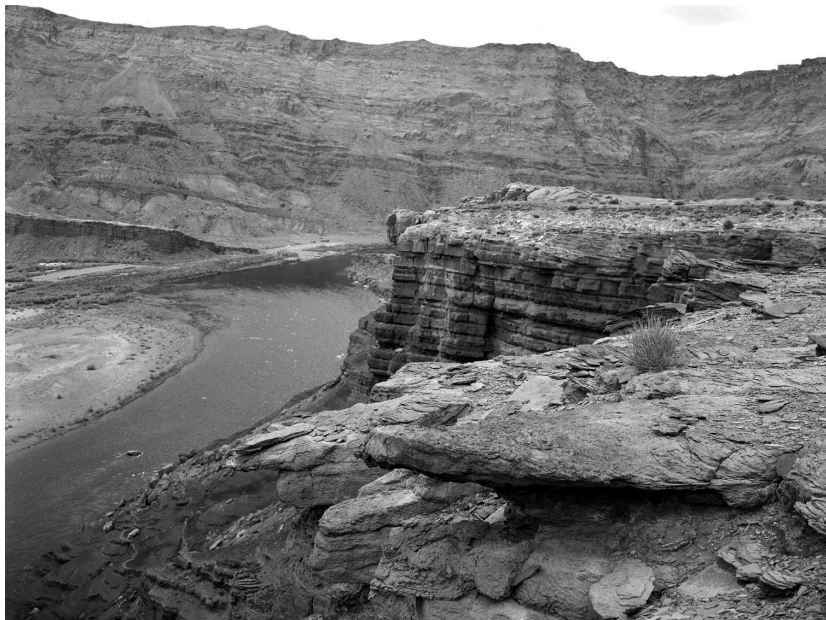
Photograph site 13.

December 28, 1889. Nims photographed the Paria Riffle and delta from Lees Backbone (northeast-facing view). Nims photograph is murky because he used paper-stripping film, which consisted of emulsion backed with butcher paper. The paper had to be coated with oil to render the image translucent enough for printing. The mouth of the Paria River is prominent on the left side and appears to have been flooded just before this photograph was taken. (*Photograph by Franklin A. Nims, 269, courtesy of the National Archives.*) **February 11, 1992.** This part of the delta, which is occasionally flooded by releases from Glen Canyon Dam, is now mostly gravel (unit gv) overlain in places by eolian sand (unit ea) and is barren of riparian vegetation. The Paria Riffle has not changed significantly; note the large rock in the center of the riffle at lower left. Several Mormon tea bushes on the Lees Backbone have persisted over the 103 years between photographs. The camera station is outside of the mapped area. (*Photograph by Theodore S. Melis, U.S. Geological Survey, Stake 2562.*)
